AMBES OIL DEPOT

Crude oil tank failure 12/01/2007

Arnaud Guéna, Emmanuelle Poupon, Mikaël Laurent

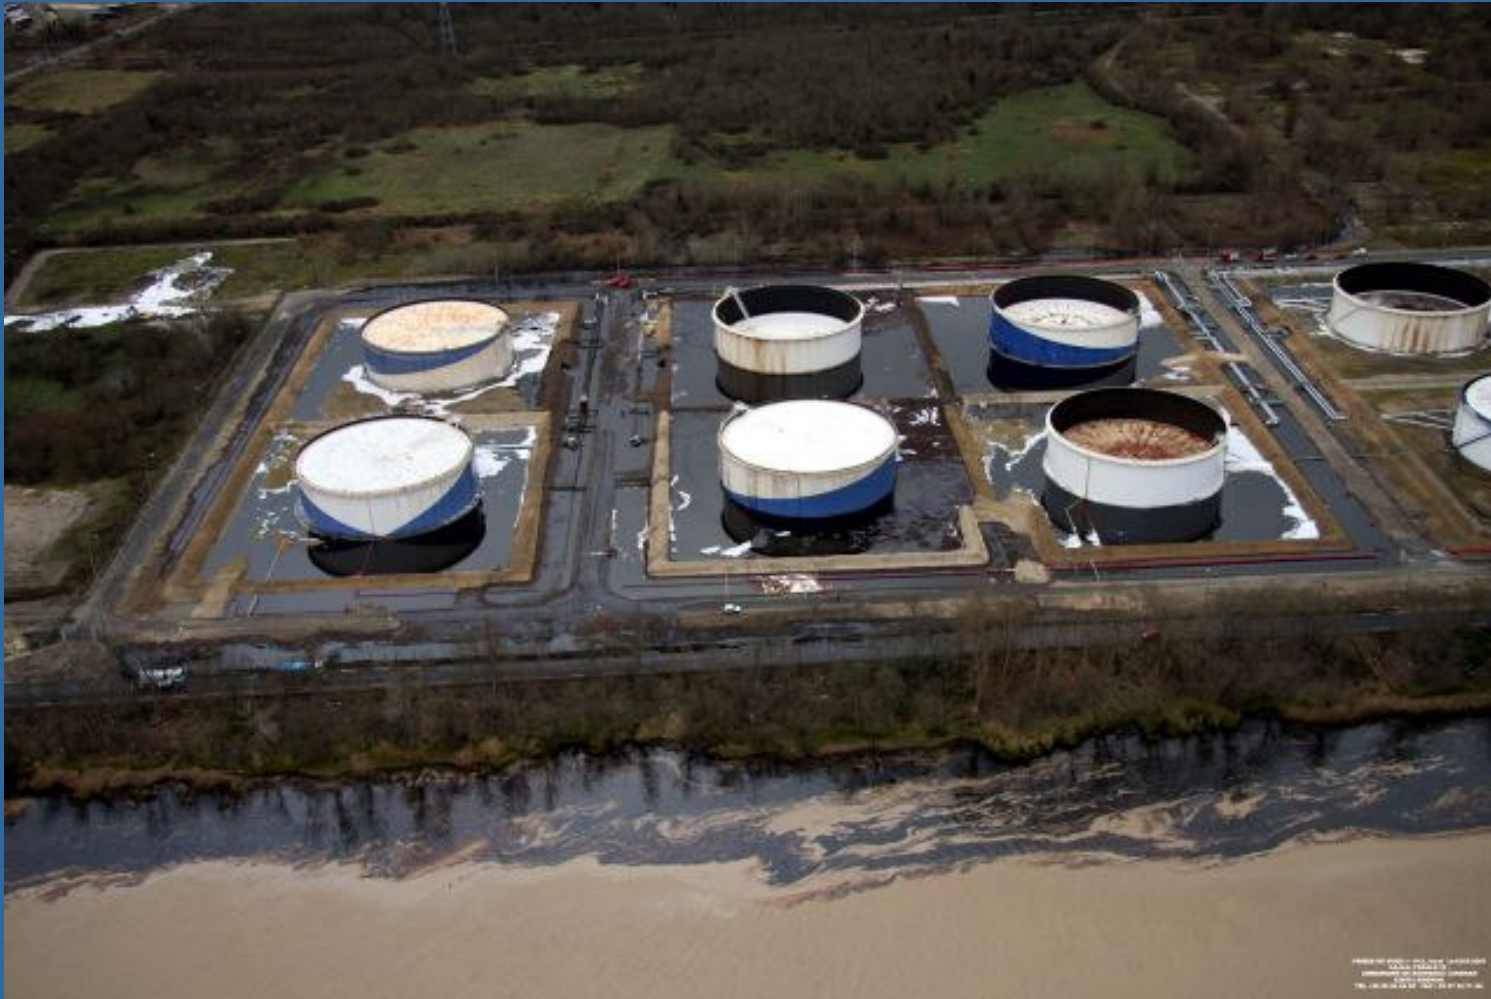
Thursday 11 January 2007 – 15h
Little leakage on tank bottom

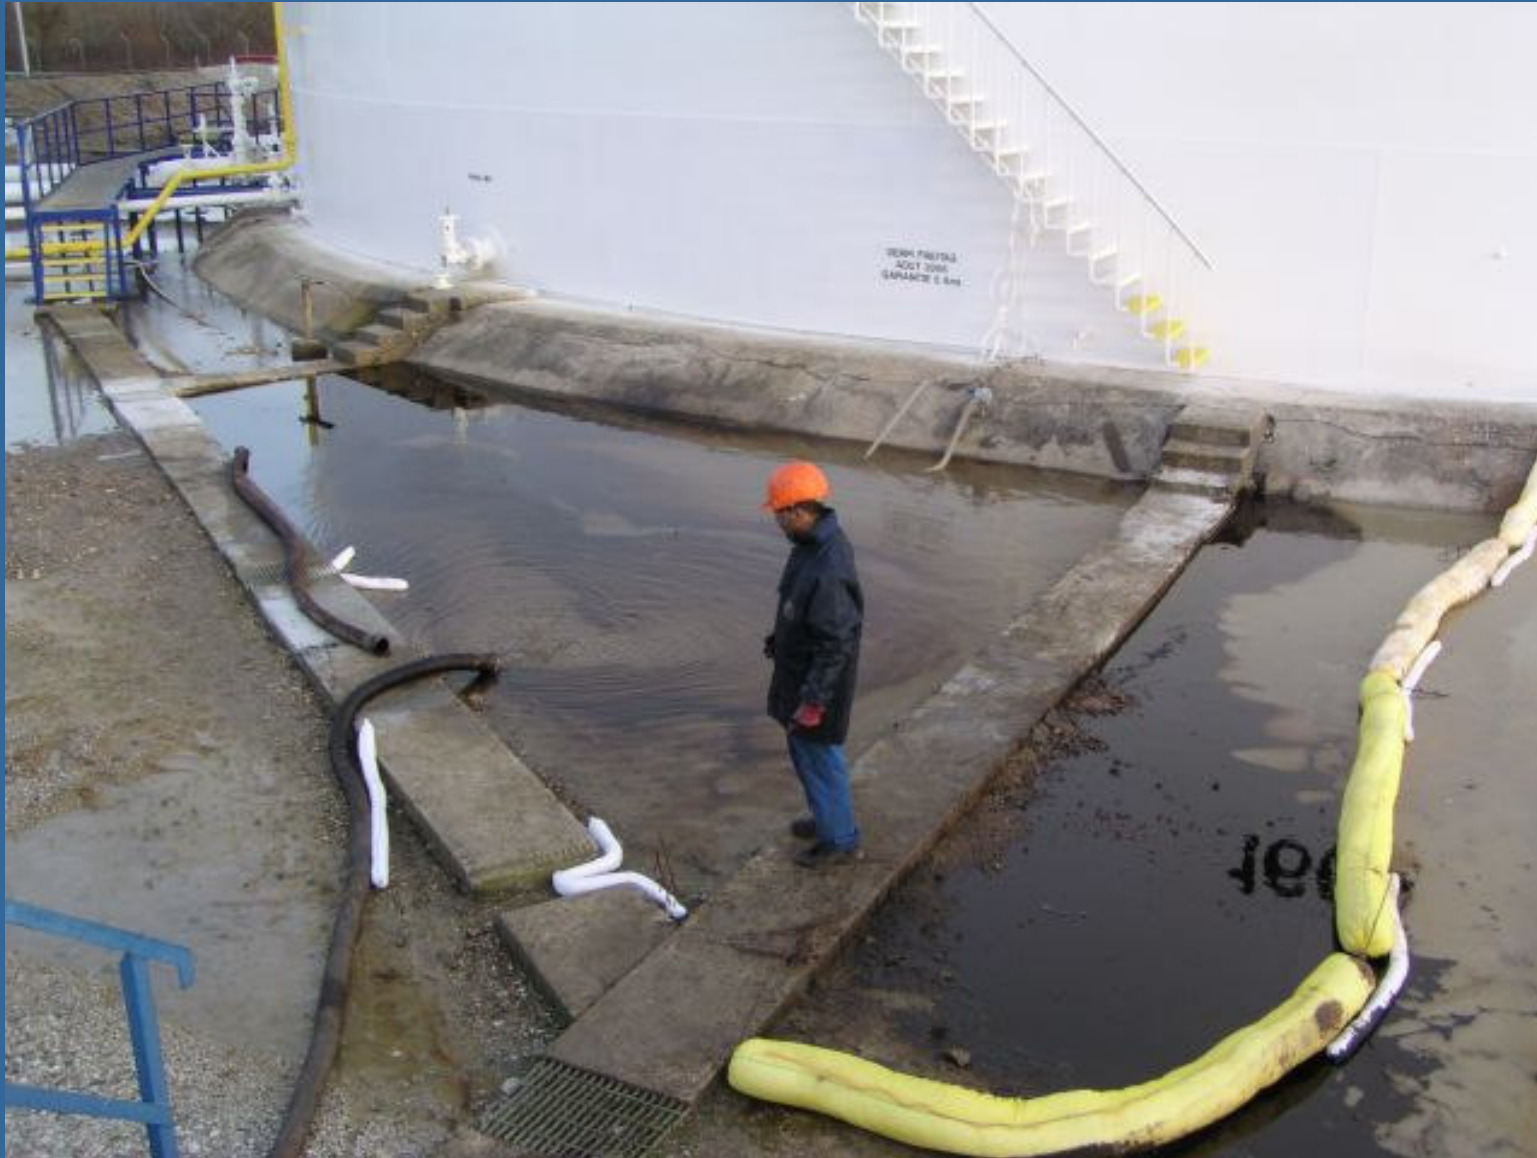
Friday 12 January 2007 – 8h

Failure of the bottom of the tank 1602

13 500 m³ (85 000 barrels) of Aquitaine crude oil spilled

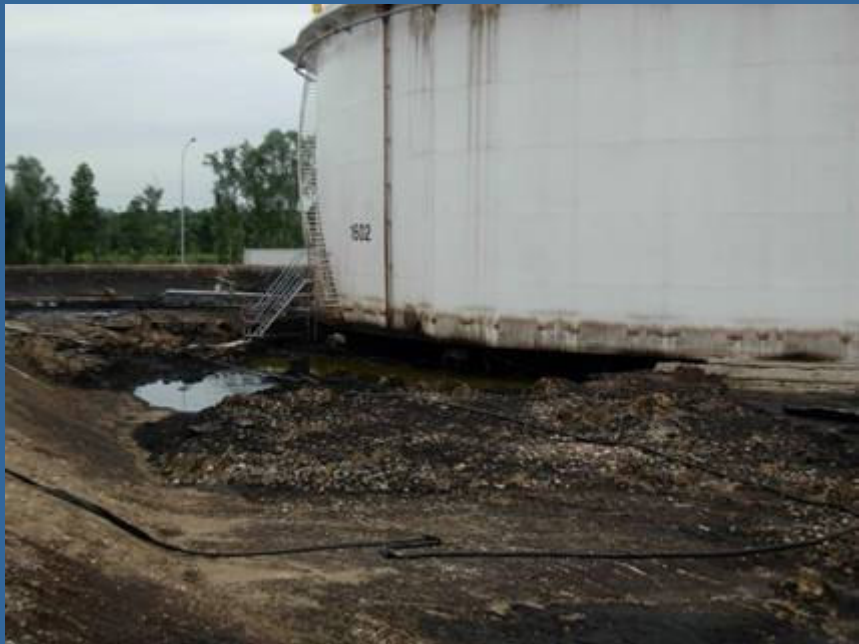
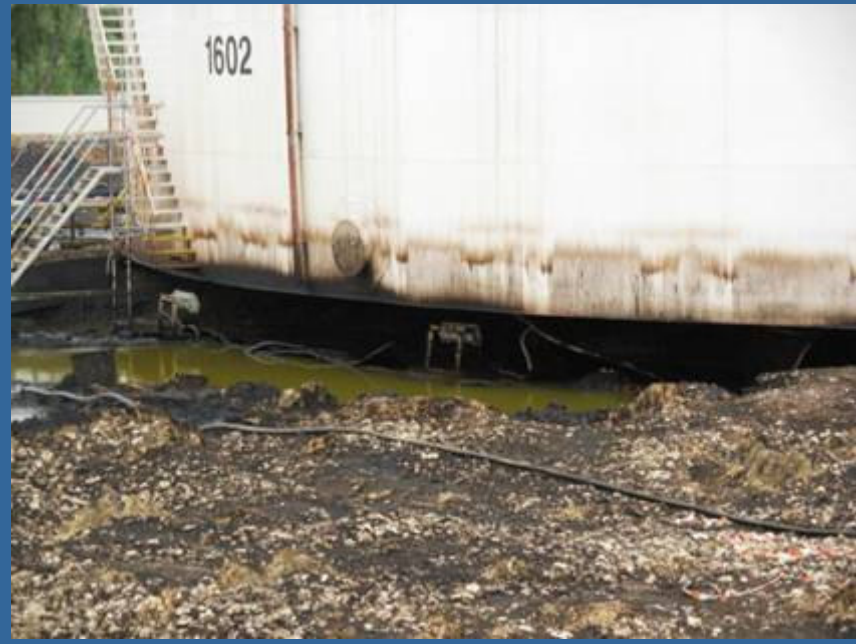
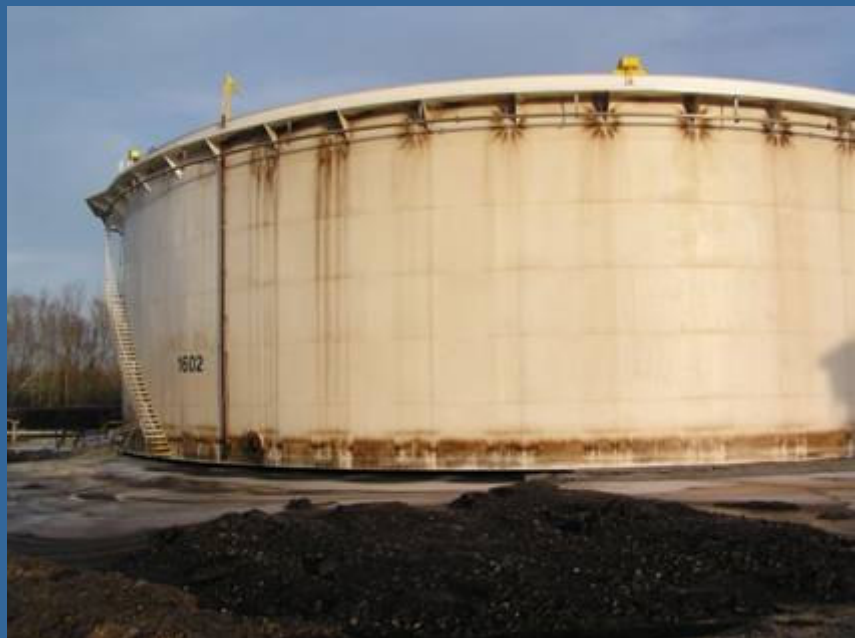
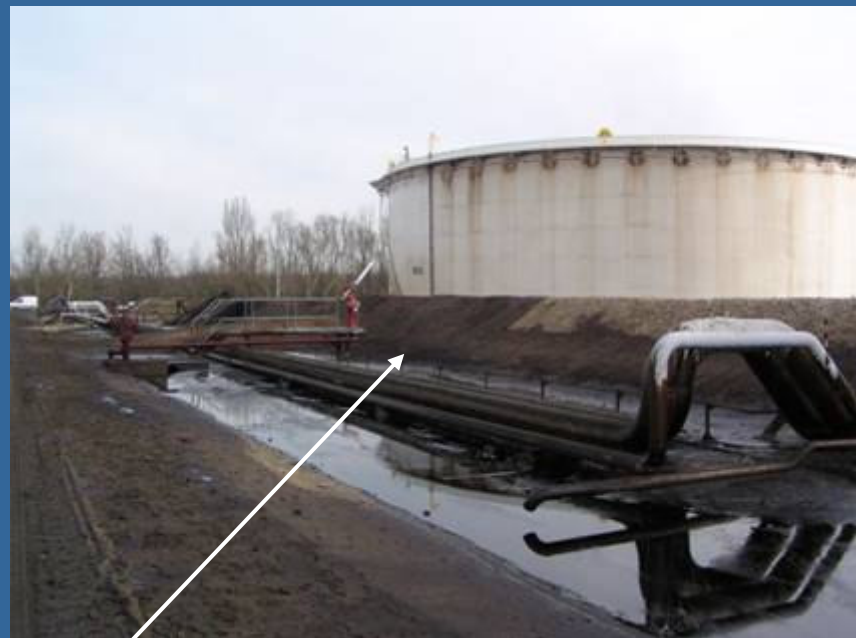
TANK BOTTOM, RETENTION POOL, WAVE EFFECT (Splash over of 2000 m³ (12600 barrels))

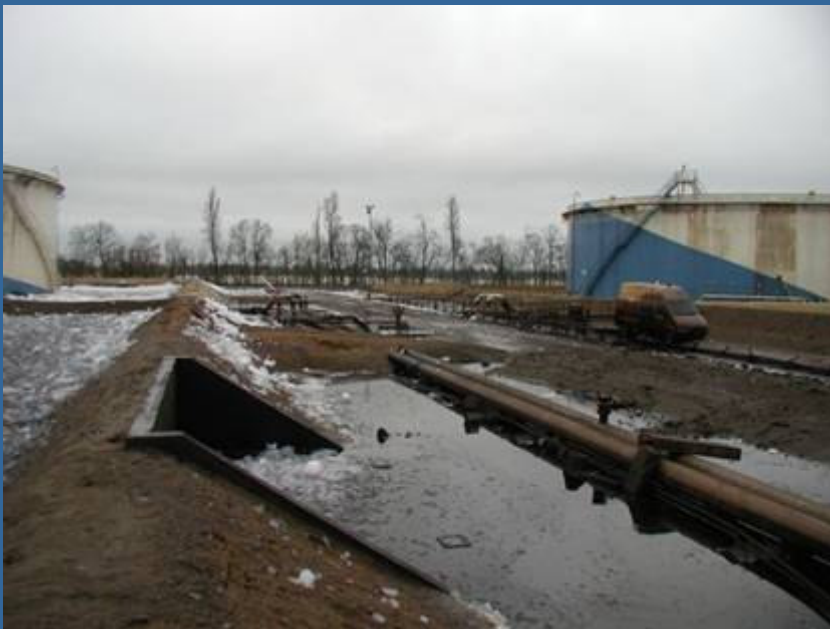
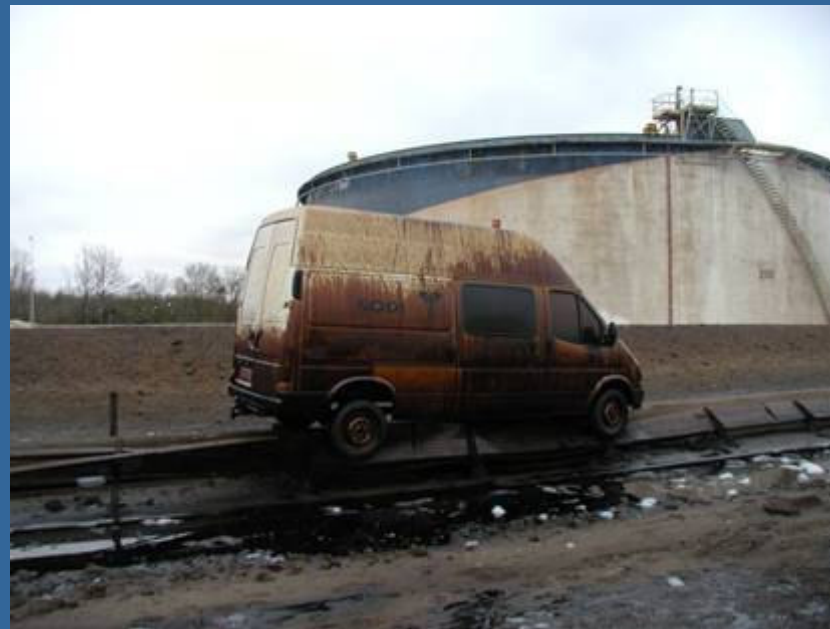
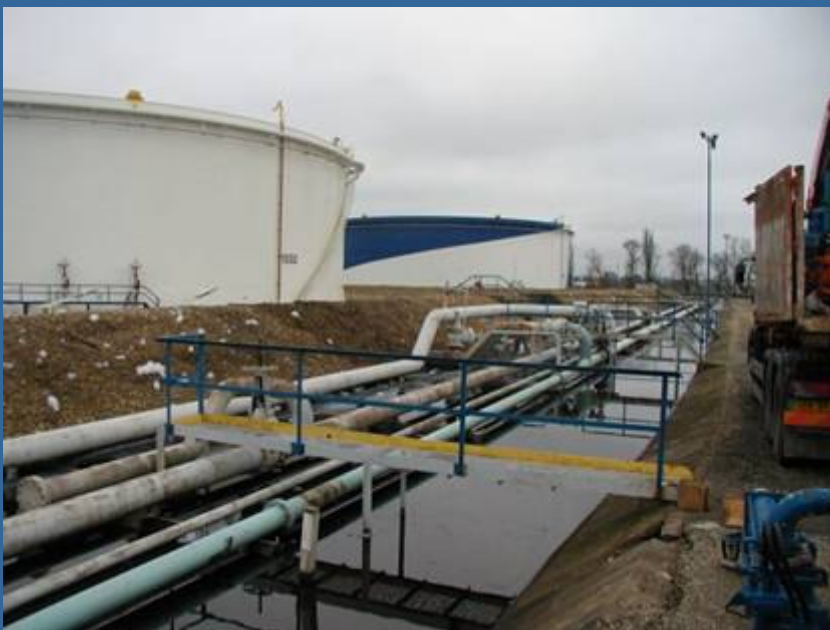
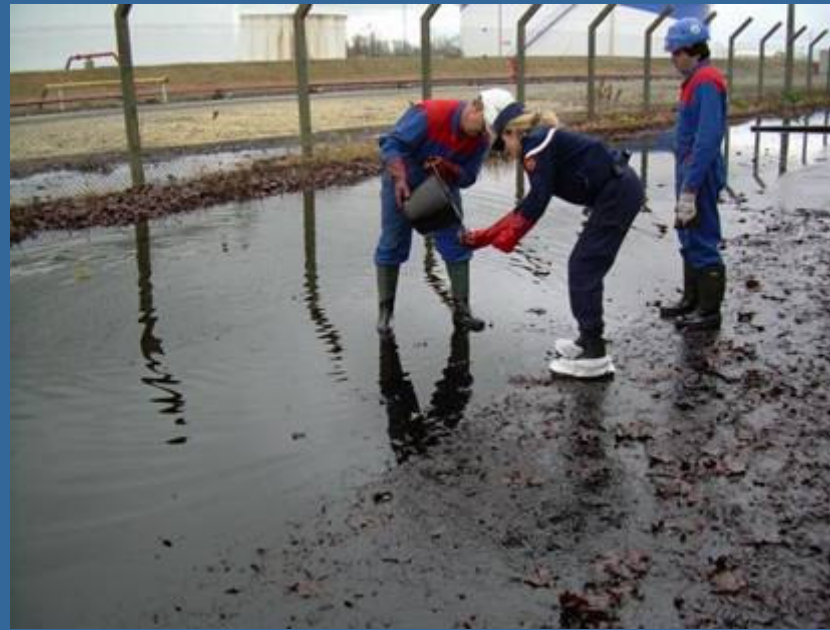
Spreading of the crude oil through drainage system and roads ...outside the depot

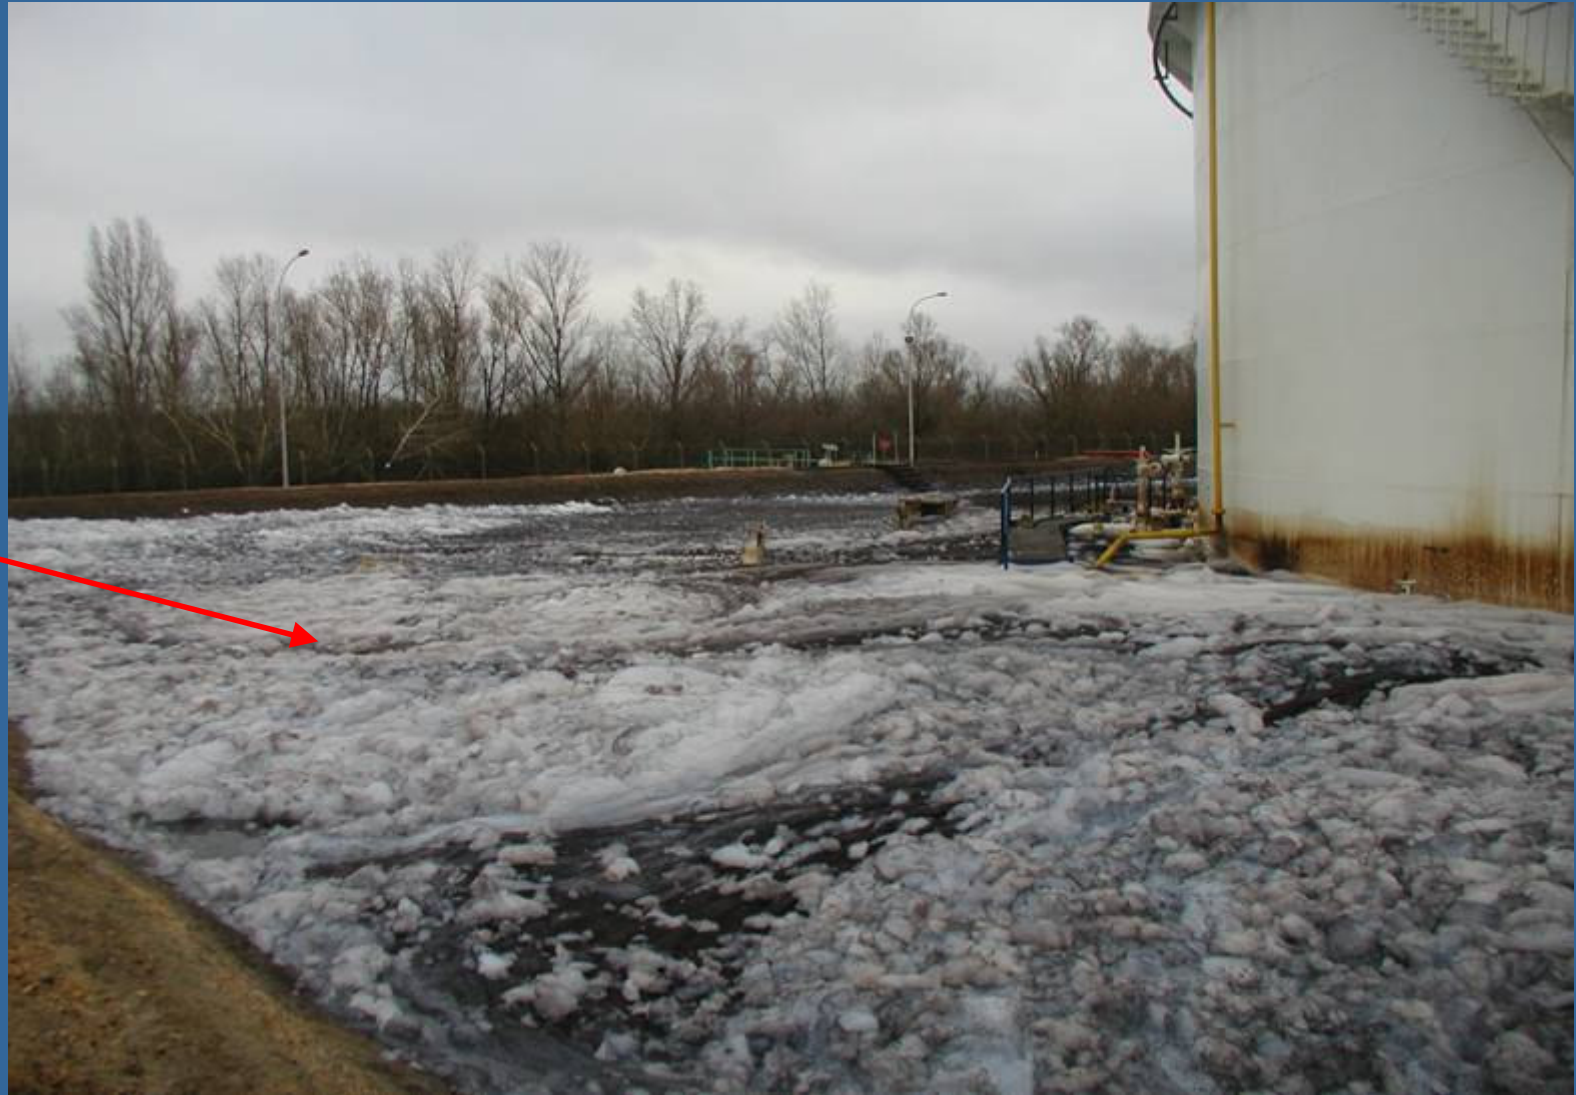
Air quality monitoring: explosive gas, hydrogen sulfide, VOC (BTEX)

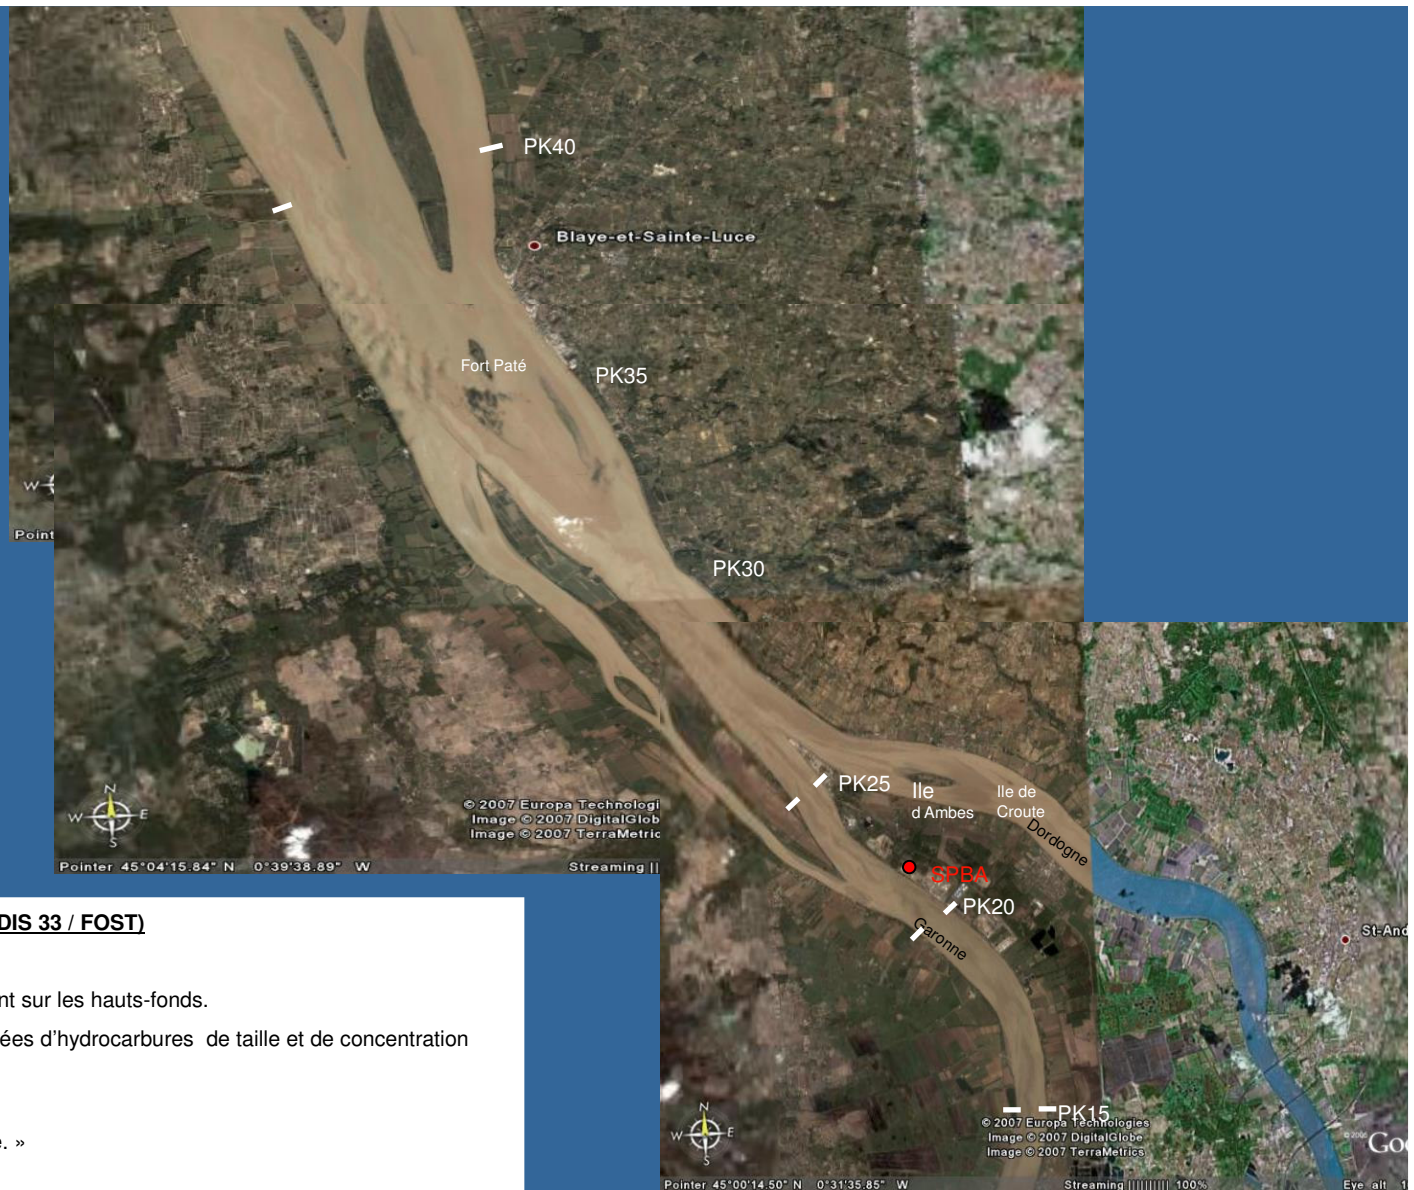
SITUATION on the 13.01.2007

Reconnaissance DRAGON 33 du 13.01.2007 (SDIS 33 / FOST)

« Entre PK 45 et PK 35 : irisations.

Au niveau de PK 35 (Blaye) : stagnation du polluant sur les hauts-fonds.

De PK 35 à PK 10 : polluant libre en surface (traînées d'hydrocarbures de taille et de concentration variables.

En amont de PK 10 : irisations

Dordogne : berges souillées jusqu'à l'île de Croute. »
